transom windows

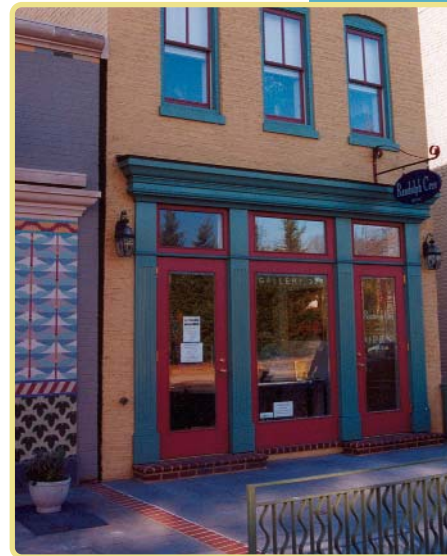
RUDOLPH CREE (CAPITOL HILL)

NOTE SUCCESSFUL USE OF PAINT ON BUILDING
